MEMORIAL HEALTHCARE

CASE STUDY

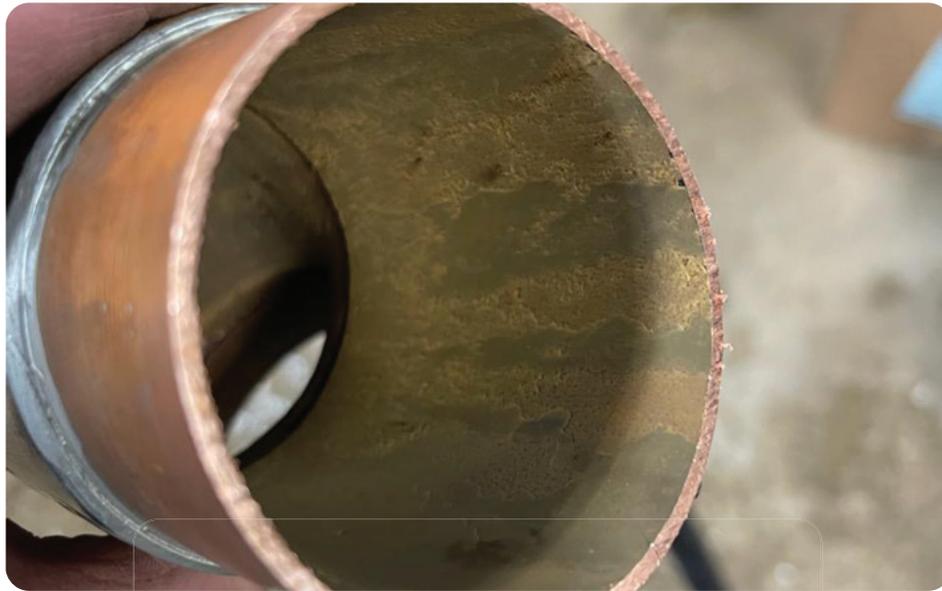
Nanobubbles starting to remove scale on a sample of pipe from Memorial Healthcare’s domestic hot water system.

SIGNIFICANT RESULTS Within months, the facilities team noticed results. The reduction in scale on copper pipes was visually confirmed when a portion of the domestic hot water pipeline was replaced in one of the buildings.
